ADDENDUM #1

Subject: **Arlington Heights Park District**

1937 Bath House at Recreation Park

MEC Project #: 25-04-0428-PD

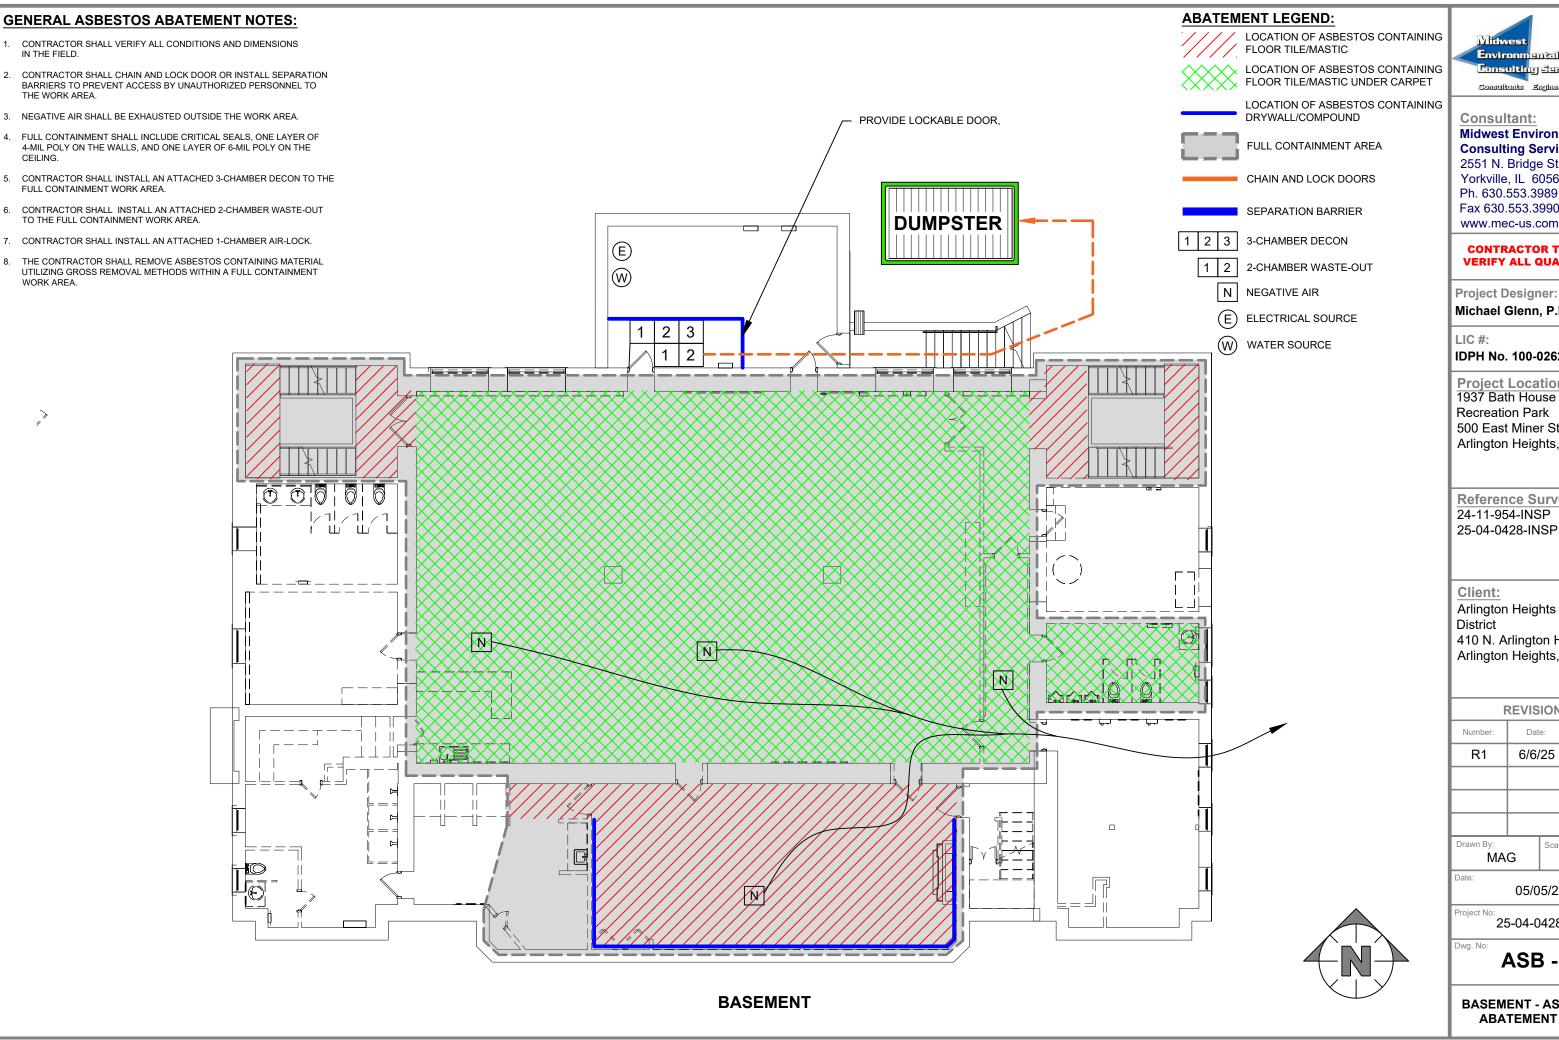
ASB - 1

BASEMENT - ASBESTOS ABATEMENT PLAN

- 2. Drawing ASB-1 Added restroom on the east side of basement with ACM floor tile/mastic to be removed.
- 3. Drawing ASB-2 Kitchen cabinetry and appliances will be removed by others prior to mobilization for Asbestos Abatement.

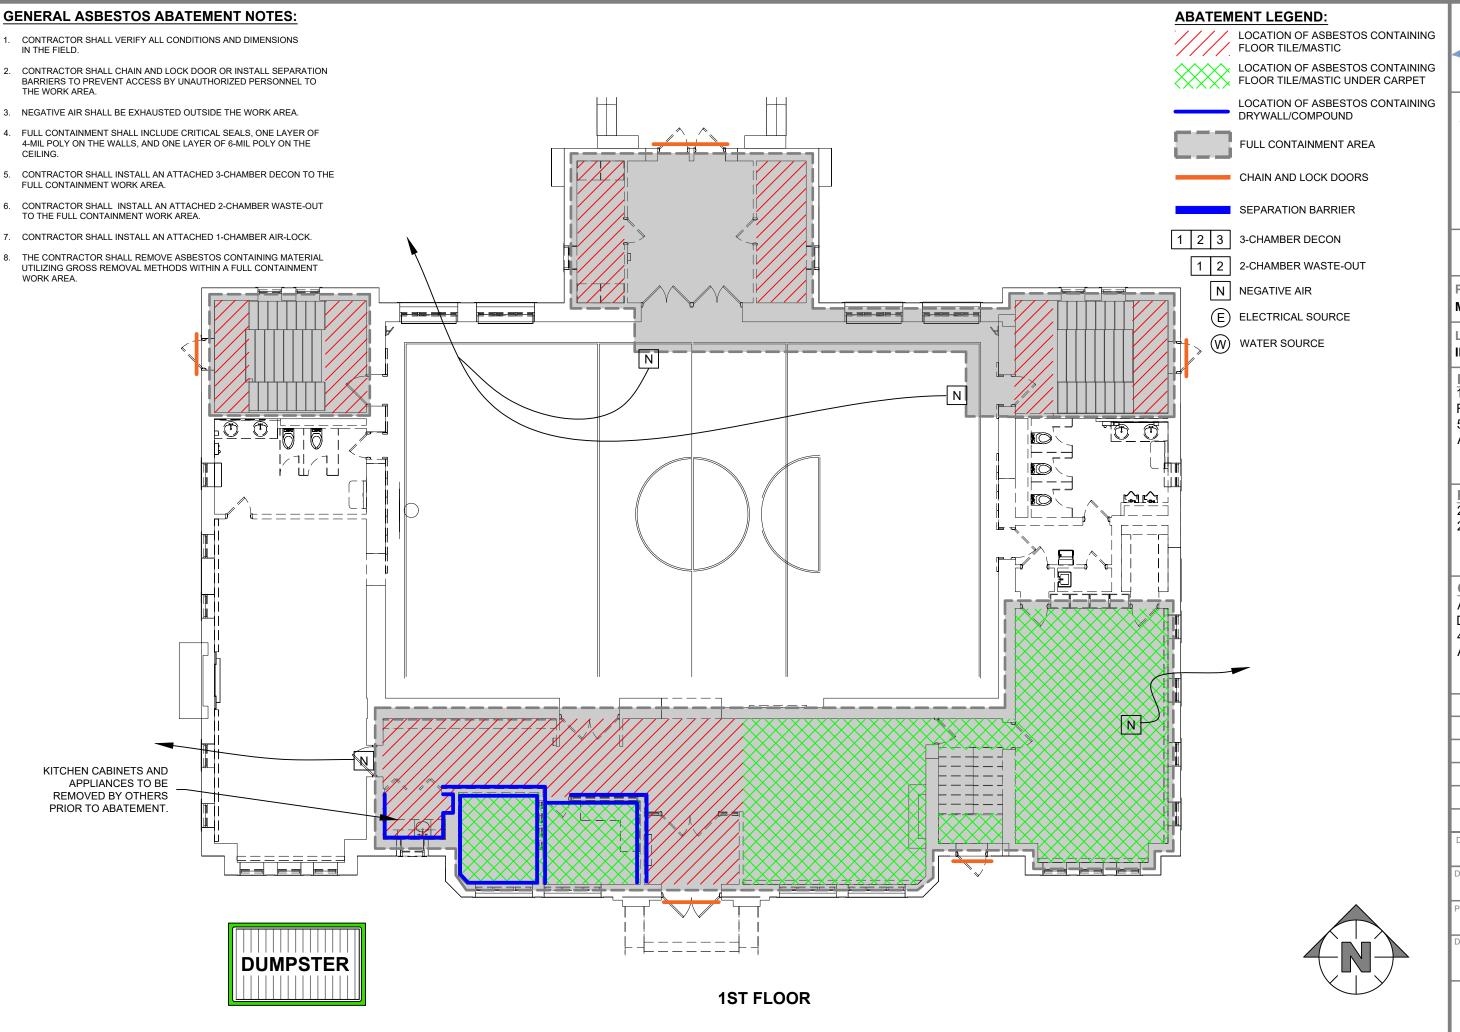
ASB - 2

1ST FLOOR - ASBESTOS ABATEMENT PLAN

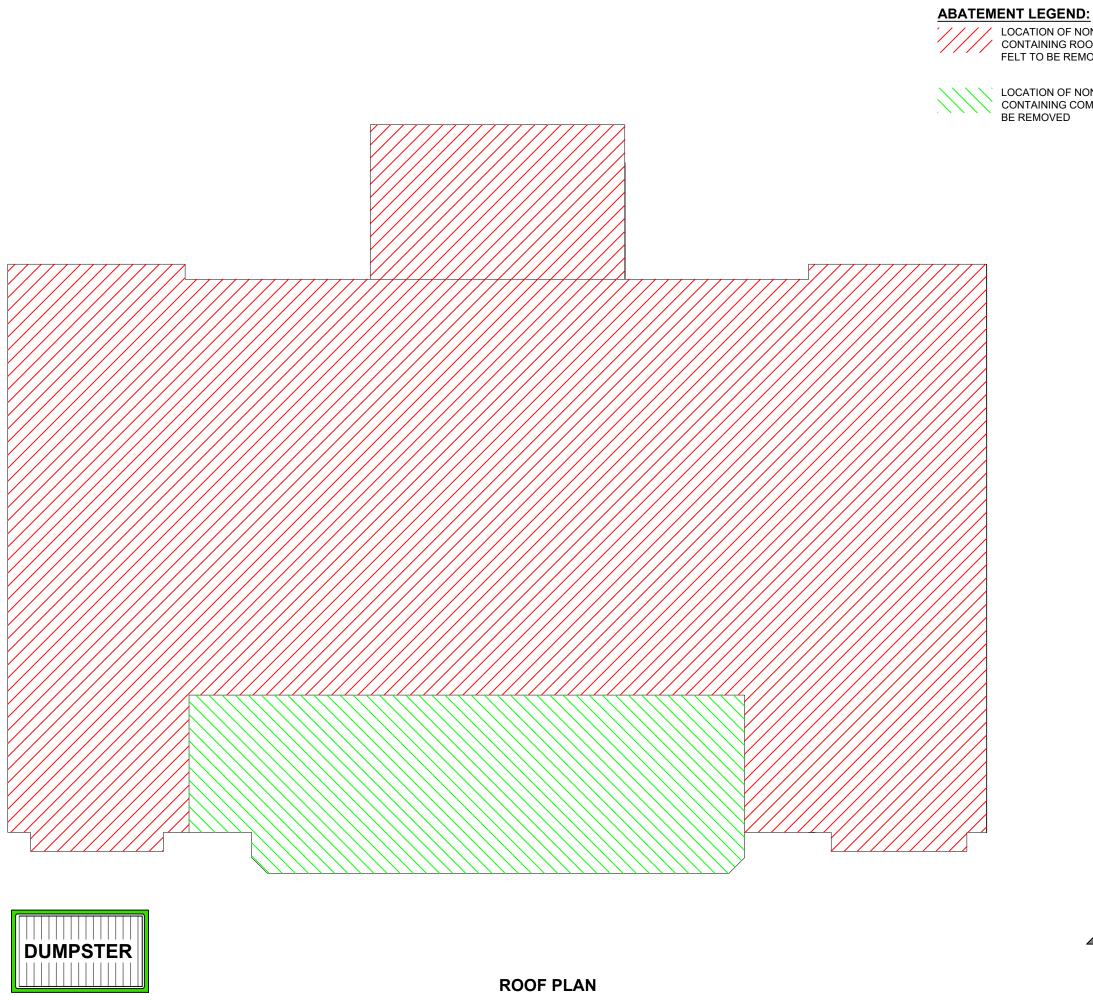
LOCATION OF NON-FRIABLE ASBESTOS CONTAINING ROOFING SHINGLES AND FELT TO BE REMOVED

- 4. ALT -1 Drawing has been added. ALT-1, Contractor will provide a cost to remove the existing roofing materials if found to contain asbestos.
- 5. This addendum does not alter the bids due date/time. Bids are due Tuesday June 17, 2025 at 11:30 a.m. at the Arlington Heights Park District Administration Offices, 410 North Arlington Heights Road , Arlington Heights, IL 60004.
